IV International Scientific Conference  
Construction Mechanics, Hydraulics & Water  
Resources Engineering  
CONMECHYDRO 2024

## Improving Impeller and Water Flow Section of Vane Pumps

“Department of “Pumping stations  
and Hydropower”

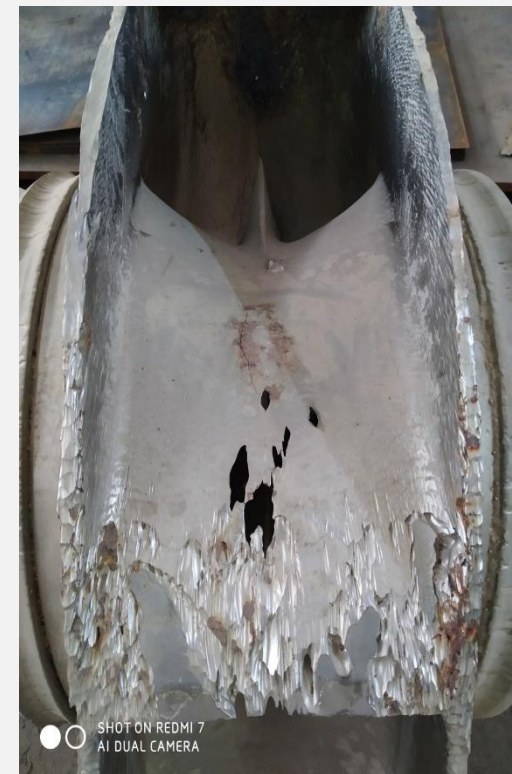
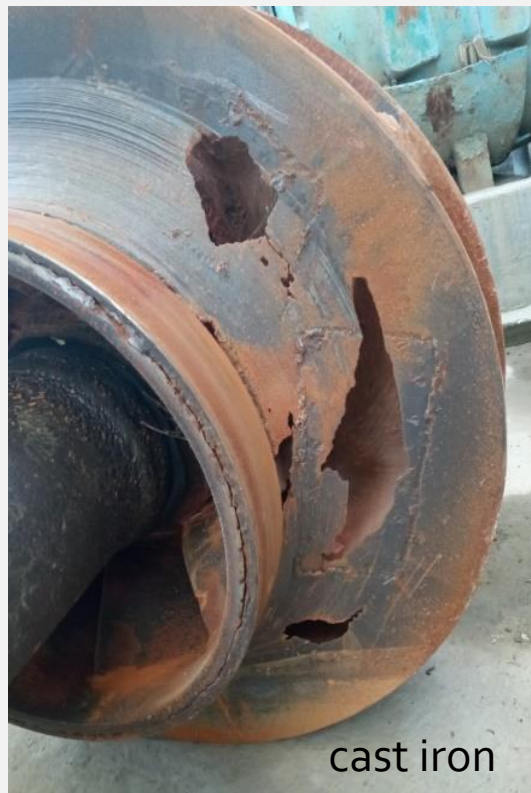
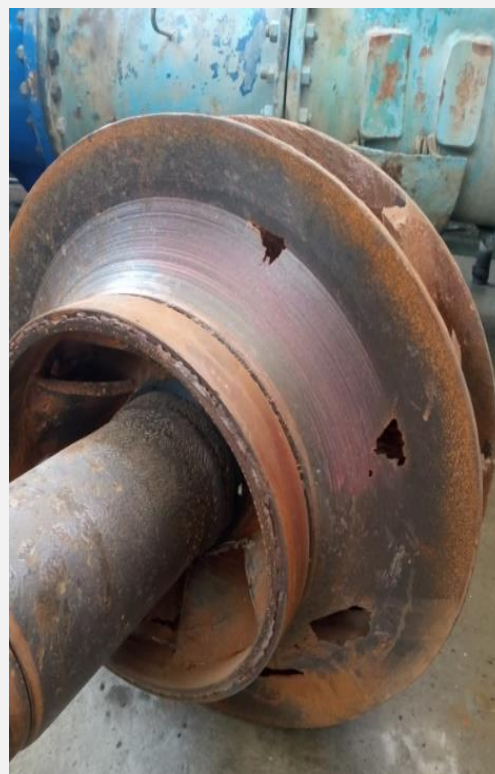
stainless steel

cast iron

**FIGURE 5.** Cavitation perforation of D-type pump impellers at the pump station of “Narpay”

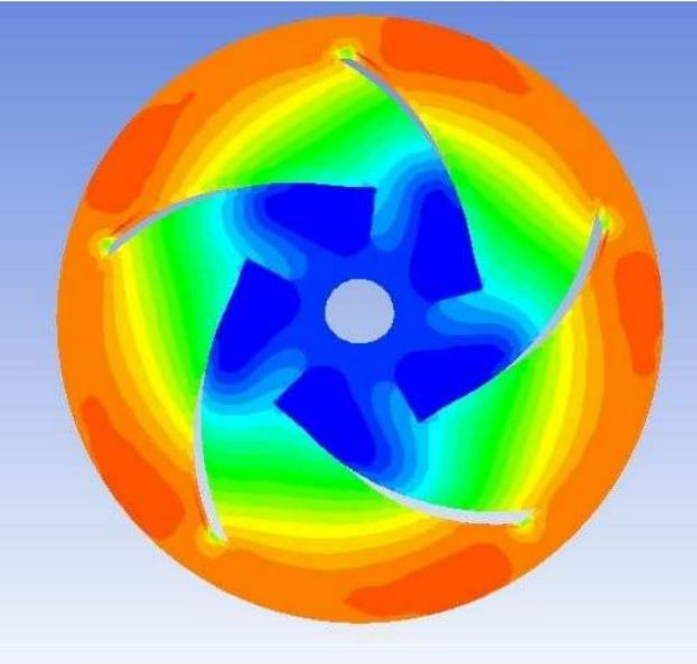
**FIGURE 7.** High pressure points in the exit zone of the impeller

When impellers were analyzed based on field observations and software calculations, it was found that under the main load, erosion occurs in the inlet and outlet sections of the working parts. Based on software calculations, the parts working under heavy load were determined and it was determined that the load depends on the input and output angular velocities(Figures 7,8). To reduce these loads, the option of cutting the impeller and designing the inlet and outlet angles to match the pump flow part was recommended (Figures 9, 10, 11).

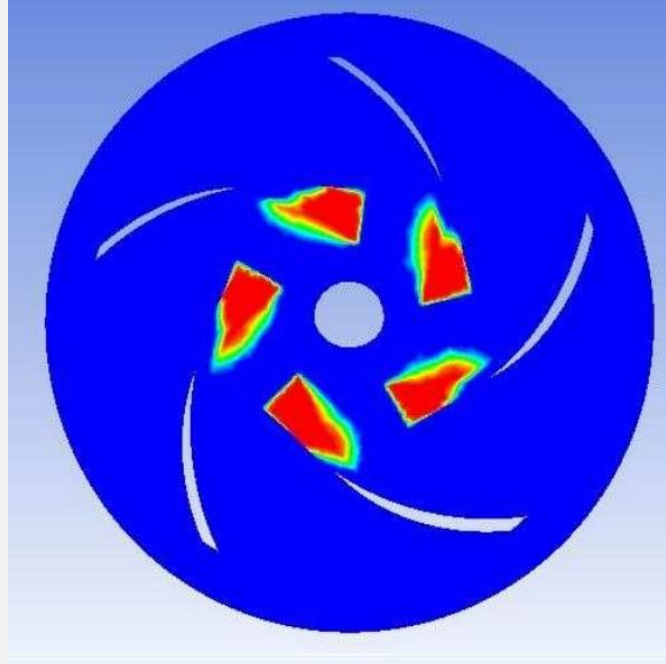
**FIGURE 8.** High pressure points at the inlet to the impeller

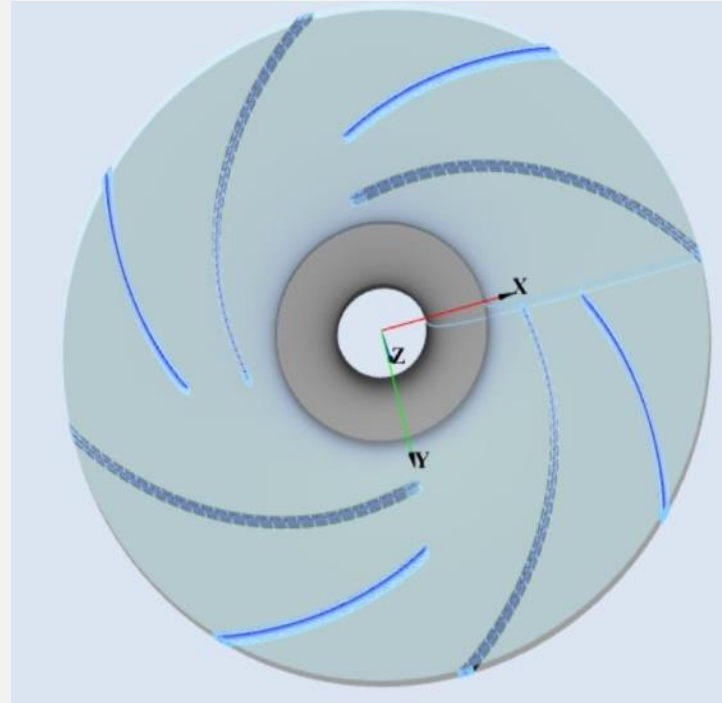
**FIGURE 10.** As a result of my software research, the version of the 8-bladed impeller blades with the water inlet cut in the odd places

In order to overcome the distortions in Figure 6, the imperfections in the impeller were studied. As a result of studies, it was found that there is an obstacle to the required water at the inlet of the impeller, that is, the required water does not reach the flow section. After that, a new view of the impeller was prepared on the basis of software calculations. In this case, the entrance parts of the impeller blades located in odd places were cut by 12% and the dynamics of the water was restored(Figures 6, 10).

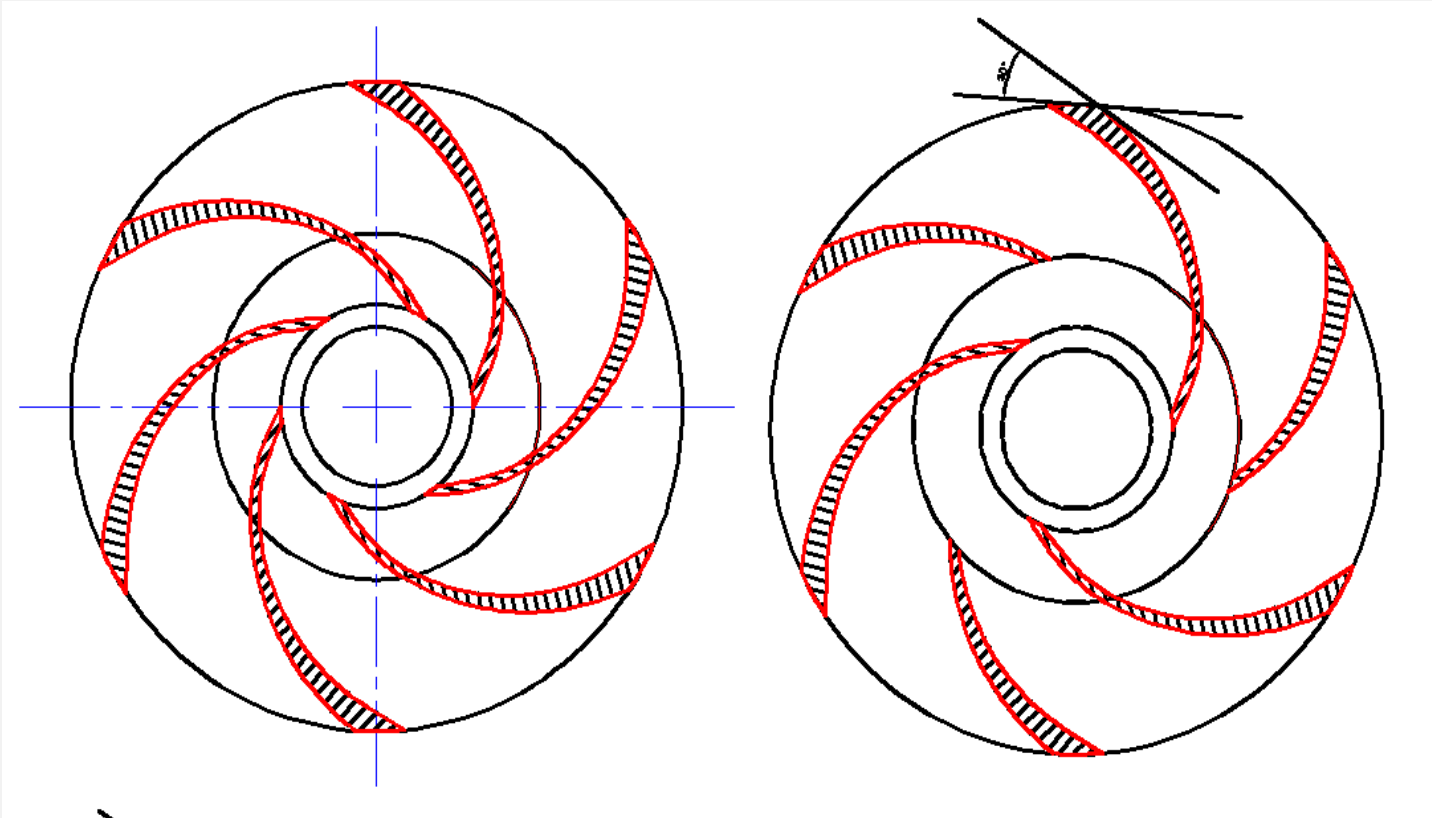
**FIGURE 6.** Uncut and cut views of the impeller

As a result, the cavitation phenomenon, vibration and noisy operation of the pump have been significantly reduced. Water consumption increased and pump capacity decreased by 4%. In the backward curved blades, i.e. the blades are bent against the direction of flow, the angle is  $\beta_2 < 90^\circ$  small,  $\text{ctg}\beta_2$  positive, and therefore the pressure decreases at the outlet,  $V_{w2}$  is minimized

7. Through the recommended impeller, water ingress at the inlet of the impeller is freed and water shortage is prevented, the cavitation level is reduced by 7% (Fig. 6).

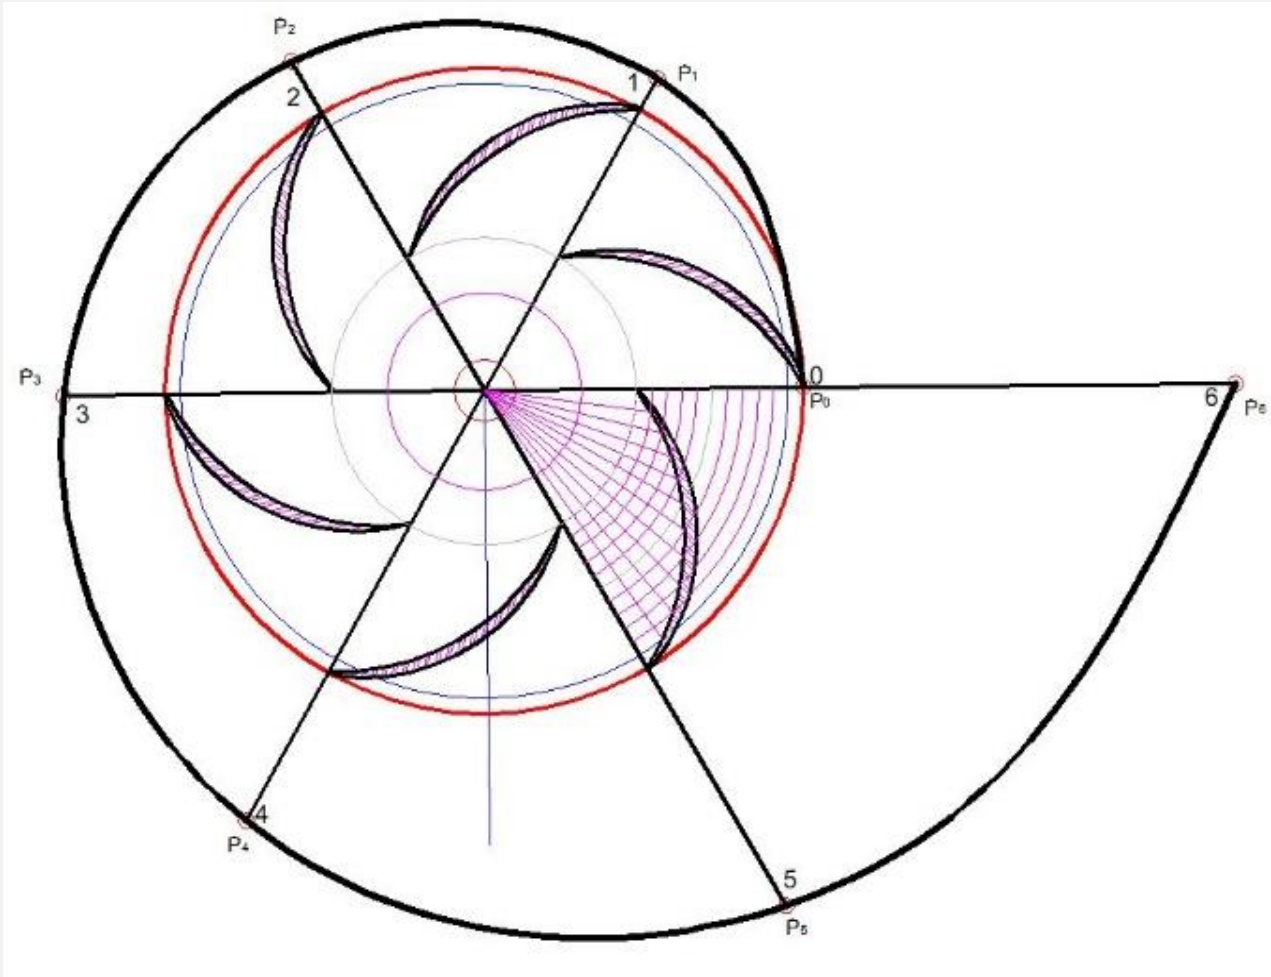
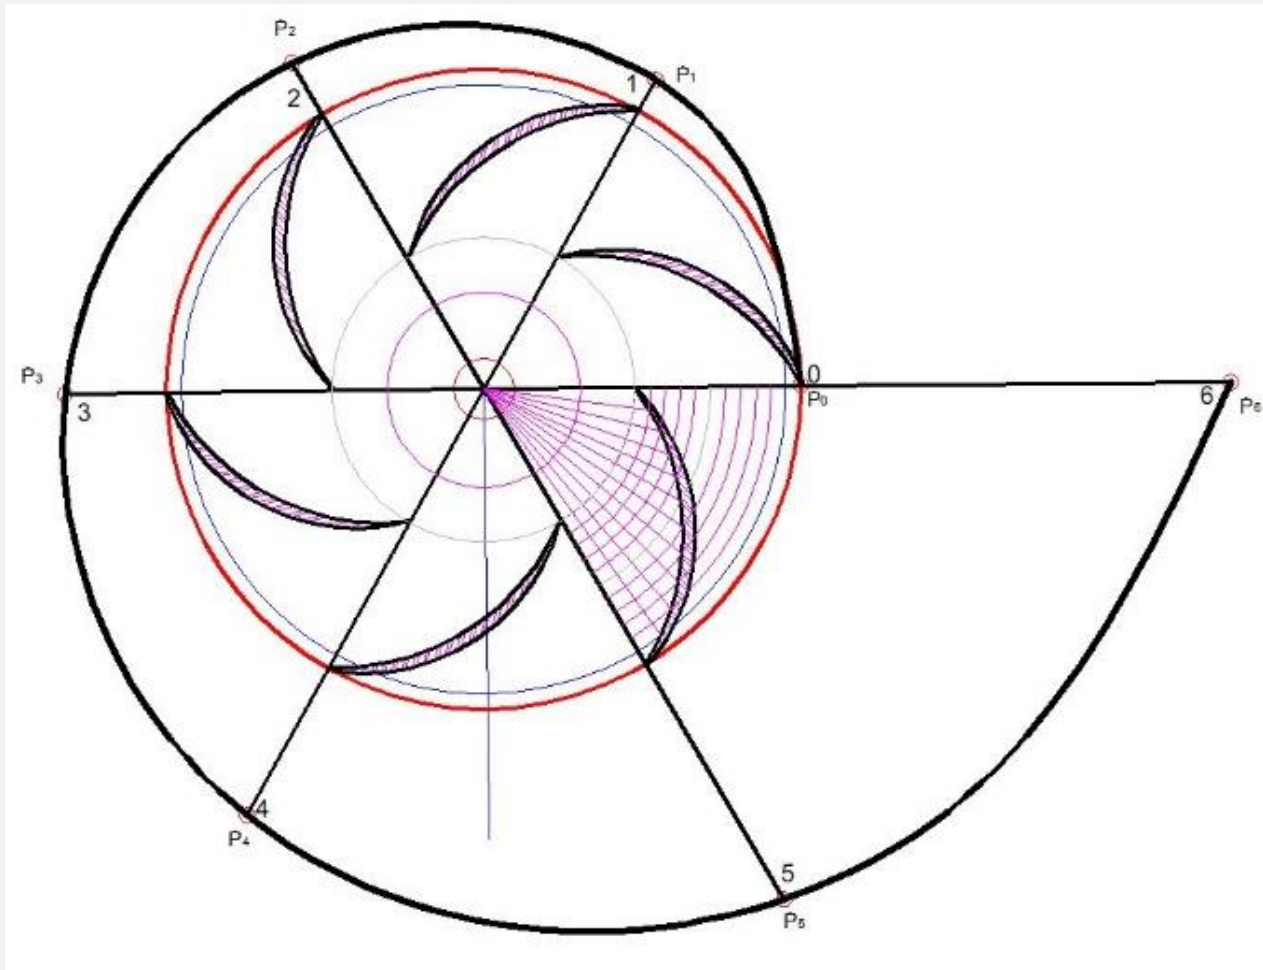
On the basis of direct field research and questionnaires, analytical studies, systematic analysis and measurement work carried out in repair shops of impellers of pumps, it became clear that the causes of high pressure in the inlet part of the impeller are the non-dynamic centrifugal force in the impeller, i.e. the violation of water continuity in the flow part, which causes these problems. It was found that the reasons for the exit were not taken into account in the design of the impeller and shell. To eliminate this disproportion, the pump impeller was redrawn to match the flow part (Fig. 11).

**FIGURE 11.** Redesign of the pump flow part in proportion to the impeller

In this case, the main focus was on adjusting the pump vanes to the diameter of the impeller, the number of vanes was selected based on the diameter of the vane, a cylindrical vane was created, and the pump was designed by dividing each vane into a separate section in the flow section. As a result, flow continuity in the pump was ensured, FIK was increased by 4% (Fig. 11). On the basis of my analysis, it was clear that back-bent blades, i.e. blades turned against the direction of flow, are preferred because of the highest FIK potential energy and the formation of cavitation is much lower. In earlier designed pumps, it was found that the flow section did not match the number of blades when divided into sections. As a result, water shortage occurred, cavitation phenomenon was observed, and the pumps worked with malfunctions (Fig. 5).
