# Results of a study of severe deformation below the damless water intake section

# Results of a Study of Severe Deformation Below the Damless Water Intake Section

**Abstract.** The paper presents the results of a full-scale study of the destruction of the banks of the lower section of the damless water intake of the KMCh. The article presents the main factors of coastal destruction during floods and low water periods. As a result of comparing field and experimental data on the intensive process of coastal collapse, a scale factor was obtained for recalculating lateral erosion. As well as studies of the process of intensive local reformation of an easily washed-out channel in the plan, hydraulic schemes for the occurrence of local erosion of the coast have been developed both with a steady and unsteady movement in an open stream. Based on the study results of intense deformation below the section of the damless water intake, recommendations were developed for protecting the banks from erosion.

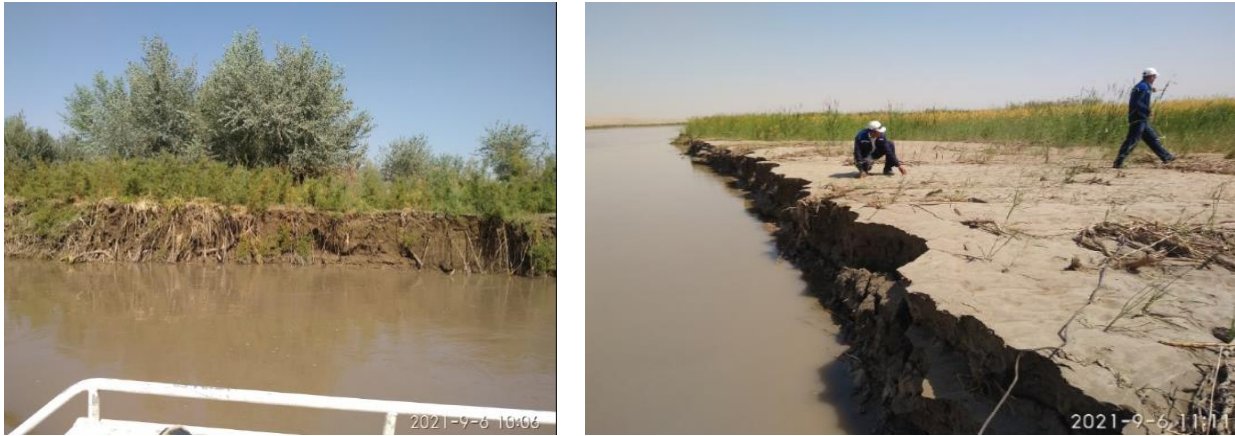
**FIGURE 1.** Observations in the lower reaches of the KMCh dam-free water intake zone to determine the intensity of the riverbed processes

Hydrometric measurements were carried out in the lower reaches of the Karshi Main Canal to determine the intensity of the flood. At the same time, the displacement rate was 1 m / day when the water level was low and 10-15 m / day when the water level was high. In winter, when the level was high, this magnitude was 4 m per day, ranging from 0.5-1.5 km to 10 km along the coast. In the direction of the stream, the left bank shifted 110 meters to the right during the period from July 7 to September 10, 2021. In 2019-2021, 15-30 meters of the Amudarya riverbank was washed away for 30-40 minutes [1].
