Factors for the efficient use of water distribution facilities

The territory where the engineering works are carried out is the “Hojabston Suv Tarmog’i” WUA (Water User Association), which is located in the “Tangir Juraev” mahalla of “Javshar” village of Payarik district, Samarqand region of the Republic of Uzbekistan [22].

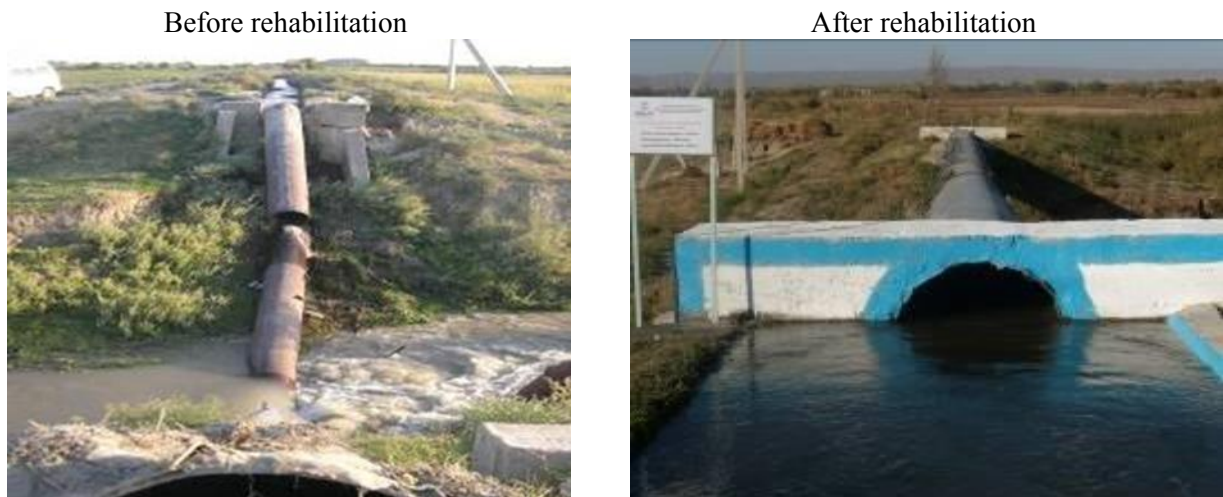
Figure 4. Aqueduct “Yangiarik”

In particular, the problems encountered before the reconstruction of the Aqueduct “Yangiarik”:

1. Water supply for 215 ha of arable land.
2. Lack of water on farms Rashit Muhammadiev (22.3 hectares), Ilhomjon Tolipov (39.3 hectares), Odil Muhammadiev (25 ha), Istiklol (27.9 ha), and Plem cattle breeders (18.6 ha).
3. Increase in salinity of irrigated area through collector irrigation.
4. Expenditures for using the pumping station for irrigation (gathering water from the collector).
5. The problem of accessing water to a lower farmer.
6. Timely water supply based on crop demand, etc.

As a result of launching Aqueduct “Yangiarik”, the following results were achieved.

1. Improved water availability for 215 hectares of arable land.
2. Rashit Muhammadiev (22.3 ha), Ilhomjon Tolipov (39.3 ha), Odil Muhammadiev (25 ha), Istiklol (27.9 ha), and Plem cattle breeders (18.6 ha) good water supply set up.
3. The increasing salinity of the sown area was prevented.
4. Energy costs for irrigation have decreased. Irrigation is provided on its own flow.
5. The problem of water supply to the nearby farmers has been eliminated.
6. Timely water supply has been established based on crop demand.
7. There was achieved a 10-15% increase in crop yields and a reduction in the negative effects of water scarcity.

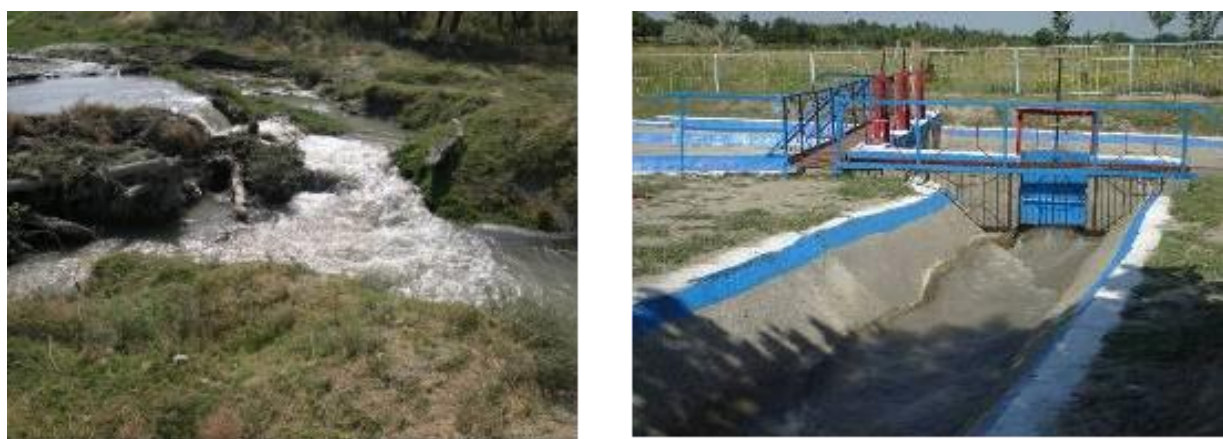
Figure 5. “Javshar-Jon” Water Distribution Point

The renovation of the “Javshar Jon” water distribution facility can save up to 22% of water.

The following problems existed before construction:

1. Lack of barrages to water distribution;
2. Inadequate distribution of water for 2013 ha of arable land;
3. Observation of soil erosion as a result of water distribution;
4. Problems related to the allocation of irrigation water to the required amount of exits
5. The problem of timely water supply and the availability of water for the following farmers;
6. Distribution of water to 49 farmers and 235 household plots;
7. Lack of water in the bottom of the canals, etc.

As a result of the reconstruction of water distribution facilities, the following indicators were achieved:

1. The water distribution facility is equipped with burgundy;
2. Improvement of water supply in 2013 hectares of arable land. 7232 beneficiaries in Damarik, Ettiurug, and Urtabuz have been improved.
3. As a result of proper water distribution, preventing soil erosion;
4. Avoidance of water distribution by irrigation;
5. Uniform water supply was achieved in the lower and middle part of the canals from the water distribution facility;
6. Improved distribution of water to 49 farmers and 235 household plots;
7. The problem of access to the bottom of the canal was solved, and so on.

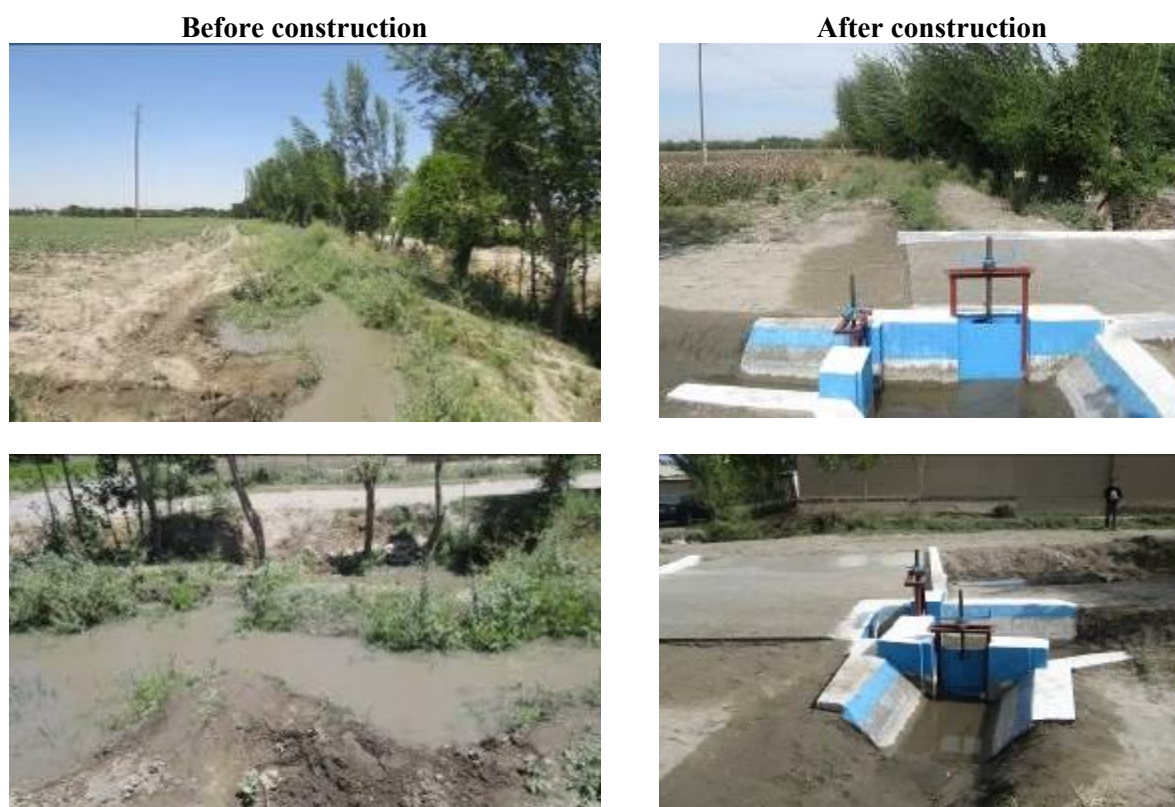
Figure 6. General view of “Asadbek” water distribution point (including the bridge)

“Asadbek” Water Distribution Facility (Fig. 6) is located in “Hojaboston Suv Tarmog’i” WUA, Poyarik District, Samarkand Region, and its service area is 30.5 hectares. Distribution of water is provided to 1 vineyard farmer (10.5 ha), one cotton-growing farmer (10 ha), and 20 gardening farms (10 ha). Stakeholders – 340 people; The water distribution facility is located in the village of “Етти упуф” with a carrying capacity of 100 l/sec. Below are photos of the water distribution facility and the newly constructed (before and after construction) conditions.

As a result of repairing the water distribution facility, water savings of up to 18% were achieved. We will look at the problems that have occurred before the construction of the water distribution facility and the results achieved after the construction of the new water distribution facilities.

Pre-construction research revealed the following problems:

1. Lack of barrages in water distribution
2. Inadequate water distribution;
3. Observation of the sludge in the ditch as a result of water contact with the soil while taking water from a watercourse;
4. Problems with the required amount of water in the irrigated field;
5. The problem of timely water supply and the problem of water supply to the fields located lower;
6. Distribution of water from 2 farmers and 20 household plots;
7. Difficulties in reaching water to the farmer at the lower parts of the canal;
8. Problems of access to machinery for harvesting and processing of crops, etc.

The following has been achieved through the construction of a new water distribution facility:

1. Water distribution is equipped with barrages;
2. The water distribution is built on the required level;
3. By equipping with barrages the distribution of water the mud accumulation was prevented;

4. The problem of water distribution in the irrigated field was eliminated;
5. Improvement of water distribution between farms and owners of the plots was achieved;
6. The issue of water reaching the lower part of the canal was solved.
7. Farmers' field facilities are provided with technical support.

The total cost for the construction of the “Asadbek” water distribution facility and the bridge was 1402 USD. Of these, farms contributed 729 USD or 52 percent.
