## The impact of hydro-wear parts of pumps for operational efficiency of the pumping station

# The impact of hydro-wear parts of pumps for operational efficiency of the pumping station.

**Abstract.** During the work considered questions of the occurrence of cavitation in hydro abrasive flows, which can lead to a rather complex phenomenon that is difficult to understand the essence of this process. Today, the wear of the working bodies of centrifugal and axial pumps, depending on the mode of their operation has not been learned much, and there has been developed a technique for selecting operating modes, taking into account the wear of their parts. Also, the results of complex laboratory and field studies on the intensity of wear of the flow elements of centrifugal and axial pumps are presented. It has been established that the alternating, pulsating load leads to an increase in the force of interaction of the hydro abrasive flow with the camera surface and increases its wear by 10 %, and also reduces the capacity of the pumping unit to 9%.

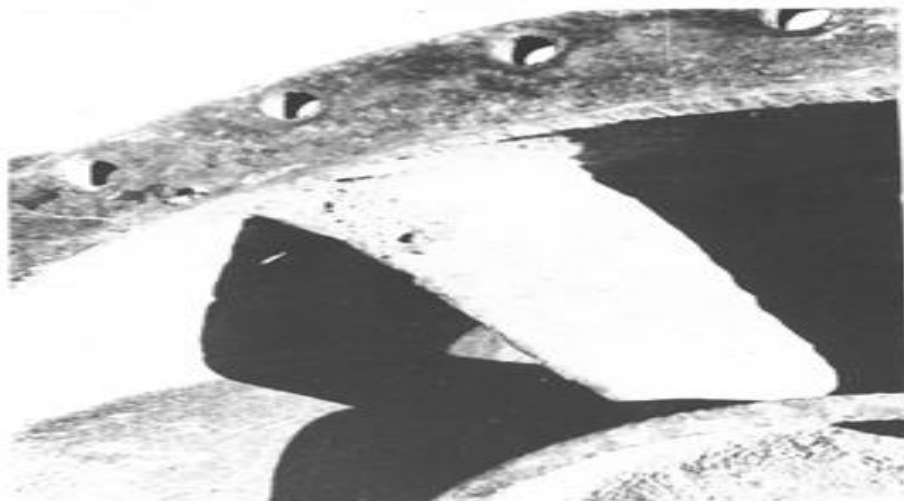
**Figure. 6.** Damage to the straightening apparatus of the pump OP10-185 PS Kuyumazar after 6100 hours of operation.

The fixed vanes of the straightening apparatuses of almost all pumps undergo cavitation-abrasive wear in the inlet part of the outer part adjacent to the rim, where flow separation and vortex formation occurs (Fig. 6). The fracture zone usually has a width of 50 to 200 mm, the erosion depth varies up to through holes, which, for example, for the OP10-185 pump, occurred after 6100 hours of operation.

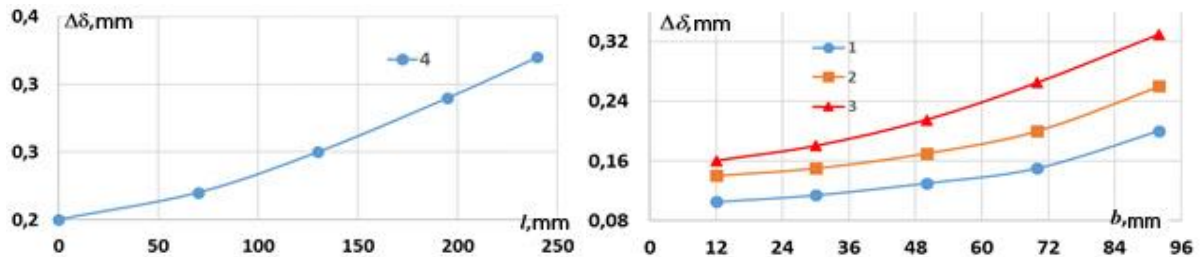
**Figure 7.** Graphs of changes in the wear thickness of the impeller blades of the axial pump along its length (a) and width (b).

Legend: 1 - for the input edge, 2 - for the output edge, 3 - for the middle part of the blade, 4 - for the peripheral part of the blade.

The nature and dynamics of wear of the working parts of the PG-35MA axial pump were studied by observing the operation of two pumping units installed in the shirkat farm of the Dangarinsky district of the Ferghana region. In the Fig. 7 illustrated the curves of changes in the wear

thickness of the axial pump blades along the length and width after 1800 hours of operation. [17, 18]. A change in the wear thickness of the impeller blades along its width shows that with an increase in the radius of the wheel, the wear intensity increases (Fig. 7, b). The dependences obtained for the input and output edges, as well as for the middle part of the blade show that in all sections the pattern of wear has a curvilinear increasing character. Moreover, the largest amount of wear corresponds to the the output, and the smallest input edge of the blade [19, 20].
