Strength investigations of foundation of allocation of main structures of Pskem hydropower station on Pskem river

Abstract. This paper presents the results of geomechanical studies of the siltstone massif experimental carried out in the right-bank adit at the site of the Pskem HPP dam. Primary shear experiments were carried out at 6 normal pressures on the stamp σ : 0.5 MPa; 1.0 MPa; 1.5 MPa; 2.0 MPa, 2.5 MPa, and 3.0 MPa.

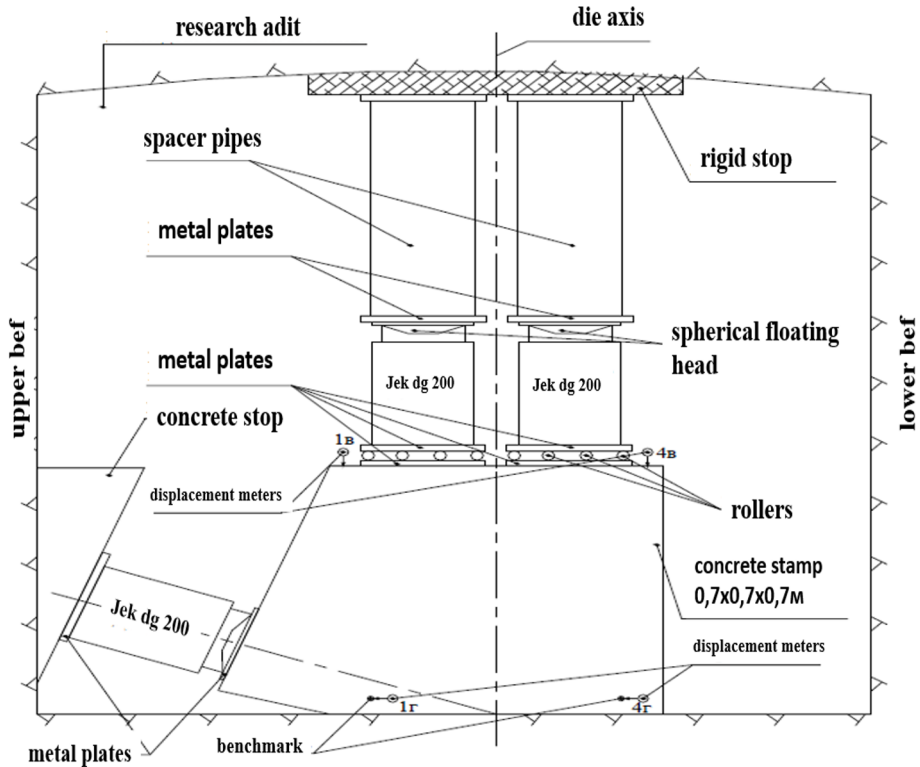
Fig 1. The scheme of shear experience

When conducting shear experiments, a momentless loading scheme is used: the direction of the shear load is set so that it passes through the center of the stamp base. In this case, the direction of the shift should be from upstream to downstream, i.e., correspond to the

During the experiments, both horizontal (in the shear direction) and vertical movements of the dies are measured with an accuracy of 0.01-0.02 mm. Measurements are carried out along 8 reference points, fixed on the upper face and in the lower part of the side faces of the stamp (Fig. 1). Each of the shift experiences is carried out in the following order. First, a given value of normal pressure is applied to the stamp. After that, the system is kept until conditional stabilization. The latter can be considered secured if, for at least 10 minutes, the rate of stamp sedimentation, controlled by the corresponding benchmarks, does not exceed one or two indicator divisions (0.01-0.02 mm).

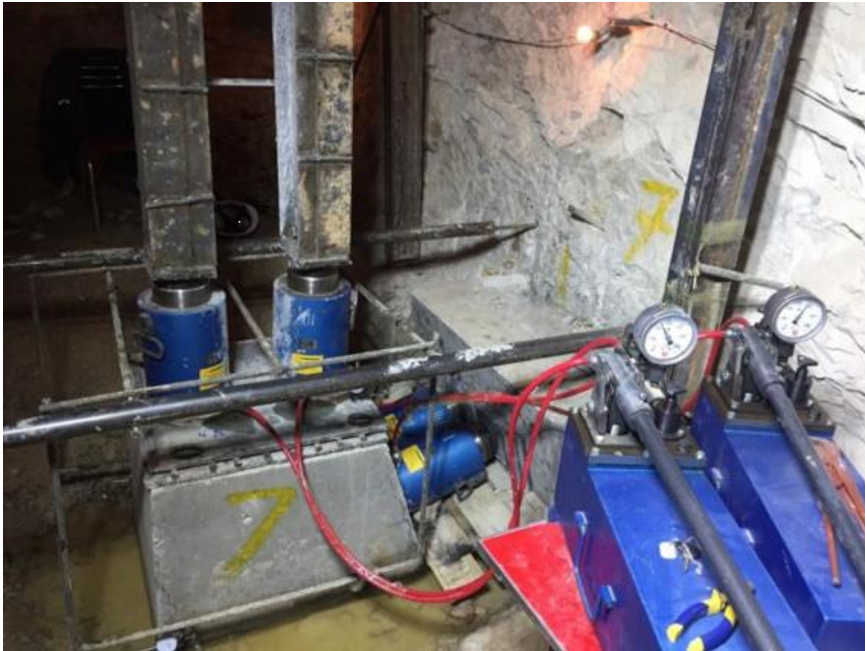
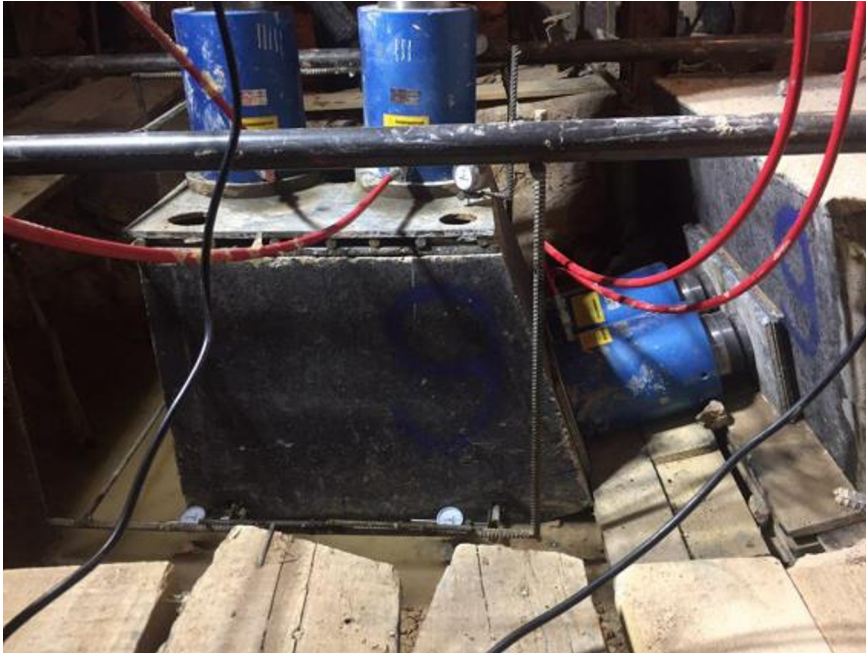
a) stamp BSh-7

b) stamp BSh-9

Fig 1. Placement of power and measuring equipment during execution of shear punch tests

Photo 1 shows concrete dies BSh-7 and BSh-9 prepared for shear testing. When performing primary shear experiments, the magnitude of the shear stress τ applied to the stamp and the horizontal u and vertical v displacements of the stamp caused by this stress were recorded. The normal stress on the stamp was kept constant. The output data from the results of the experiments were the ultimate shear strength τ_{sr} , the horizontal movement of the stamp u_{pr} , at which the ultimate strength and residual shear strength τ_{res} were achieved (during the second shear). The results of each completed shear experiment were presented as dependences of the horizontal displacements of the stamp u on the magnitude of the shear (tangential) stresses τ . The indicated graphic dependencies, as well as the dependencies of the vertical displacements of the stamps $v=f(\tau)$,

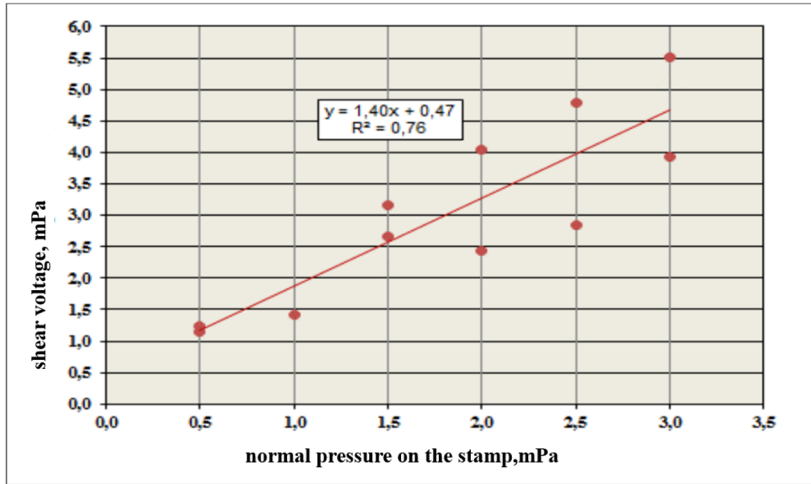
Fig 2. Dependence of ultimate shear strength on value of specific normal load on concrete stamps BSh-7 ÷ BSh-12

The results of the remaining 11 primary shear experiments are shown in fig. 2. By statistical processing of the obtained results, the following normative values of shear parameters were obtained - friction coefficient $\text{tg}\phi$ and adhesion C : $\text{tg}\phi_H = 1.40$, $C_H = 0.47$ MPa.

The corresponding Coulomb dependence of the ultimate shear strength on the value of the normal pressure applied to the stamp has the following form:

$$\tau_{pr} = 1.40 \sigma + 0.47, \text{ MPa}$$

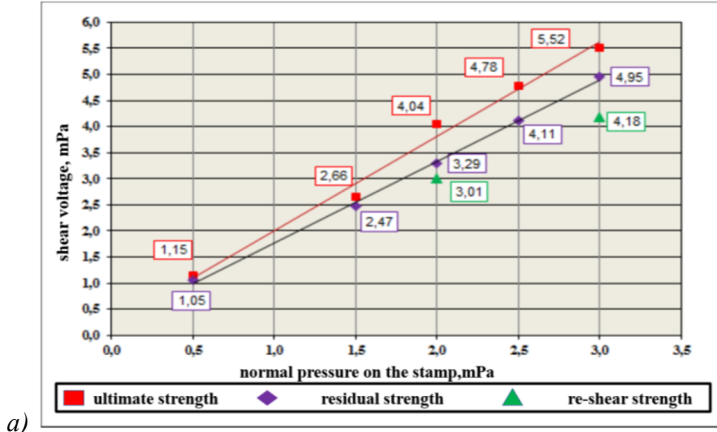
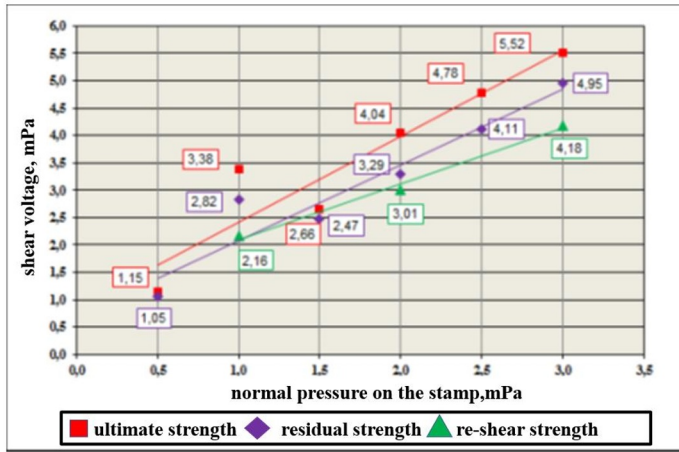
Fig 3. Values of ultimate τ_{sr} and residual τ_{res} shear strength obtained in primary shear tests (second shear) and in repeated tests without taking into account (a) and taking into account (b) data on the BSh-8 stamp.

The value of residual strength tres can be estimated from the results of primary experiments, in which the die displacements were fixed after reaching the ultimate strength (second shear experiments on each die). In Fig.2. shows a comparison of the values of limiting tres and residual tres of shear strength obtained in the experiments under consideration (respectively, without taking into account and taking into account the data of the second shear on the BSh-8 stamp), performed on the same dies. In Fig.3, the primary experiments (second shift) data are compared with the data from all repeated experiments.

Analysis of the given data shows that the residual shear strength determined during primary experiments is less than the ultimate strength by 7.1÷18.6%, with an average value of about 12%. According to the results of repeated shifts performed in the range of normal stresses of 1÷3 MPa, the residual shear strength was obtained less than the ultimate strength by 14.2%-36.1% with an average value of about 25%.

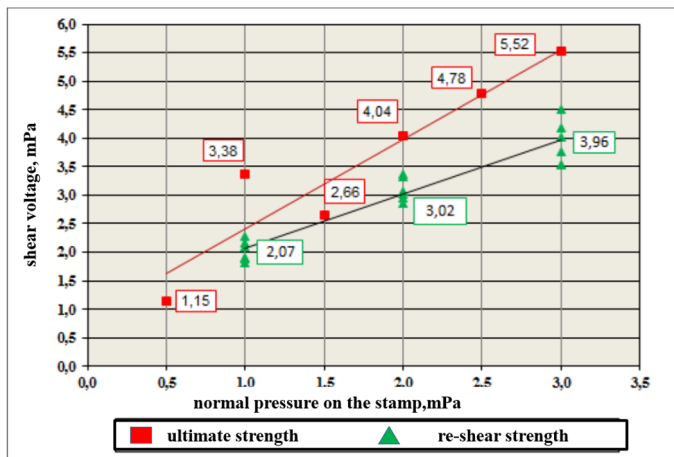
Fig 4. Comparison of ultimate shear strength τ_{sr} obtained in primary shear tests (second shear) with shear strength obtained in all repeated tests.

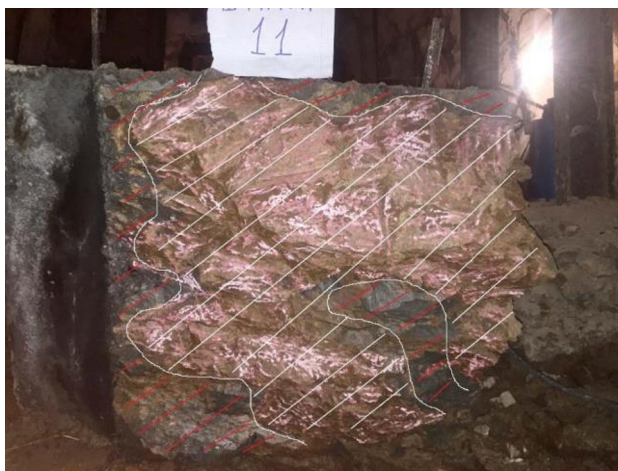
Fig 5. Shear surface after testing dies No. 11.

After completion of the shear tests, the dies were overturned, and the resulting shear surface (cleavage) was sketched. Such a survey made it possible to reveal the nature of the destruction and determine the areas along which the shear surface passed.

For example, photo 2 shows a snapshot of the shear surface obtained when testing stamp No. 11. In the photograph, the part of the shear surface that passed through the massif is highlighted with a white stroke along the “concrete-rock” contact, with a red stroke. As you can see, the shear surface mostly passed through the array in this case.
