IV International Scientific Conference  
Construction Mechanics, Hydraulics & Water  
Resources Engineering  
CONMECHYDRO 2024

## Improving Impeller and Water Flow Section of Vane Pumps

“Department of “Pumping stations  
and Hydropower”

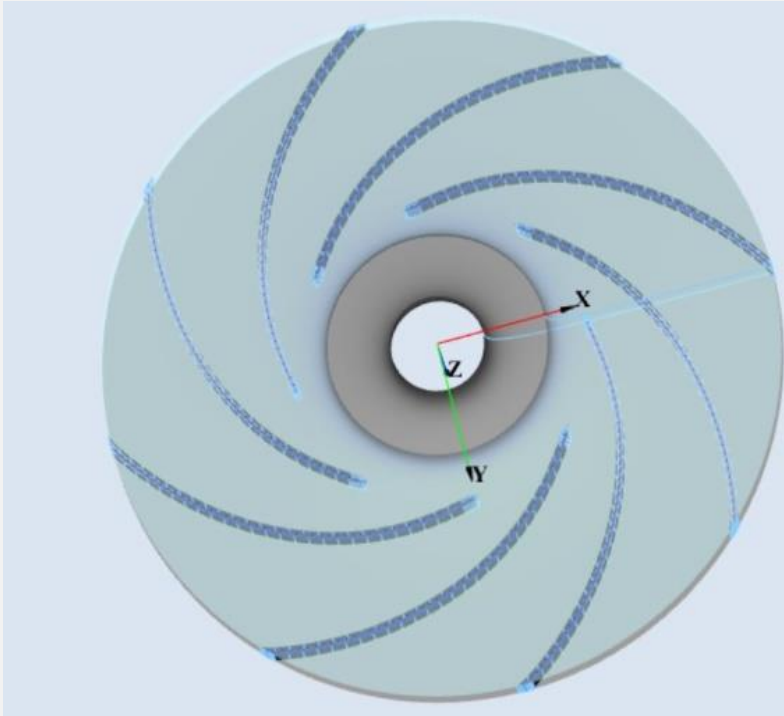
**FIGURE 9.** 8-blade impeller drawn by software

When impellers were analyzed based on field observations and software calculations, it was found that under the main load, erosion occurs in the inlet and outlet sections of the working parts. Based on software calculations, the parts working under heavy load were determined and it was determined that the load depends on the input and output angular velocities(Figures 7,8). To reduce these loads, the option of cutting the impeller and designing the inlet and outlet angles to match the pump flow part was recommended (Figures 9, 10, 11).
