Water resource saving in irrigation networks through improving the efficiency of reinforced concrete coatings

To cite this article: F Kattakulov *et al* 2020 *IOP Conf. Ser.: Mater. Sci. Eng.* **883** 012053

F Kattakulov¹, T Muslimov¹, A Khusainov¹, Sh Sharopov¹, O Vokhidov¹^[0000-0001-8786-0078] and Sh Sultanov²^[0000-0002-7461-5740]

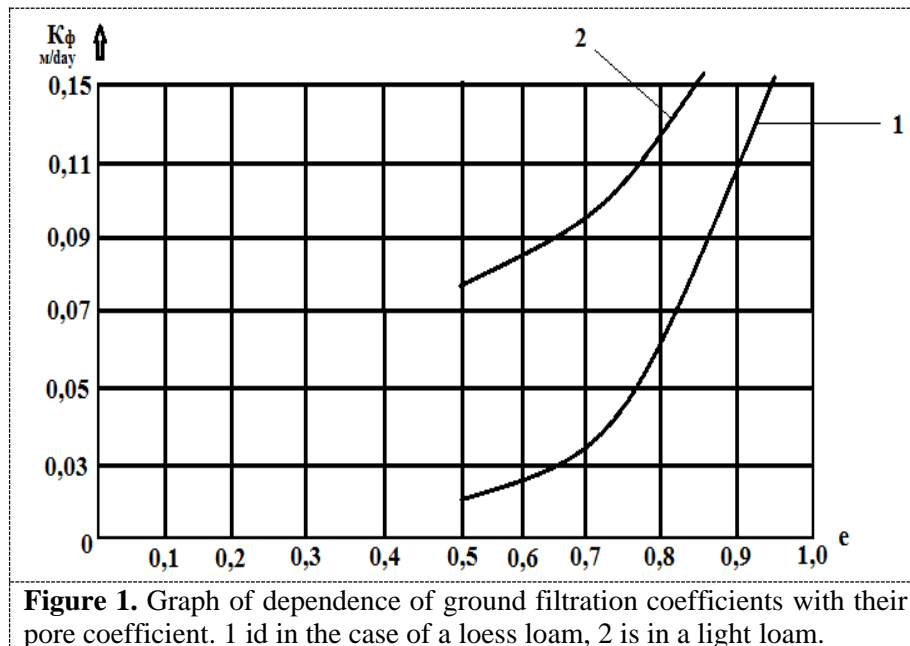
The underground filtration rate depends on many factors. For example, the pore coefficient of the soil depends on the shape and size of the soil particles, the mineralogical composition, and the active porosity [9]. Although the different pore coefficients are the same, their permeability may be different. Figure 1 below shows the correlation coefficient of filtration coefficients in the fluorescent sorrel and light sorrel ground.

From the graph above, it is fair noting that even though the soil pore coefficients are the same, their active porosity is relatively high for the relatively large number of sand particles in light hydrocarbons, hence the increase in their permeability. Soil permeability is the property of the soil to transmit water and air and is one of the most important qualities [10].

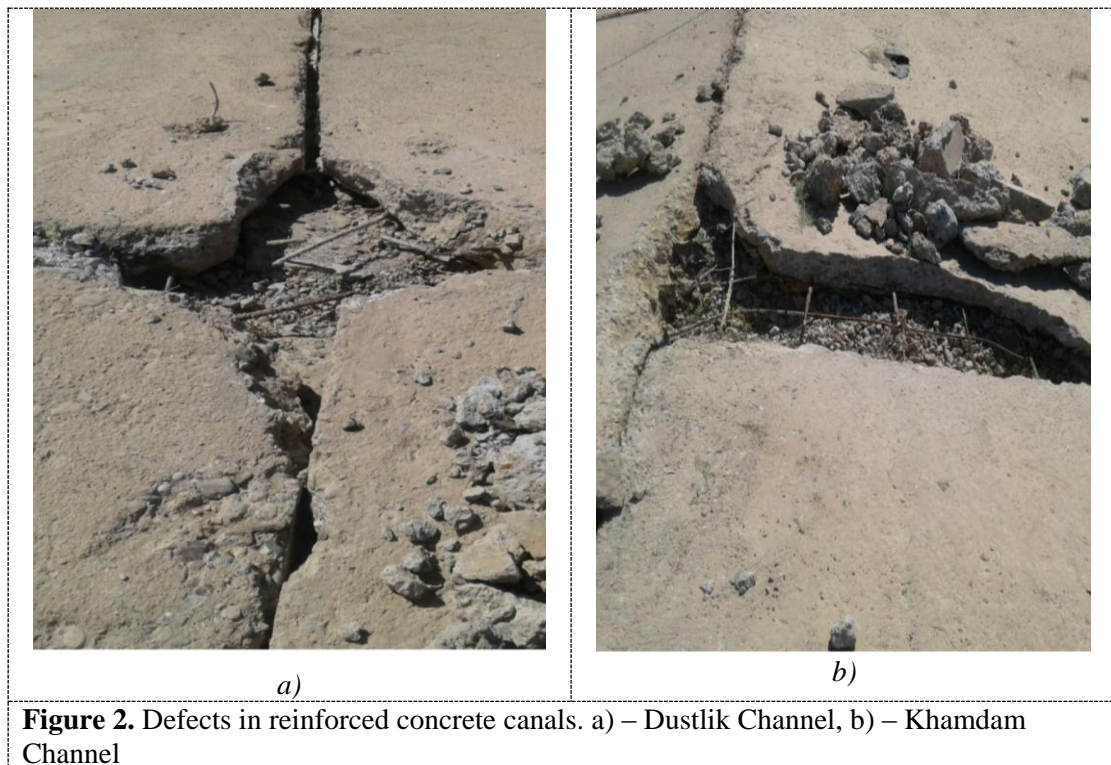
Based on the above, it is important to note that during the construction and operation of irrigation canals, it is desirable to cover sand and sandy sections of the canal along the longitudinal direction of the canal with the concrete slabs. The current technical condition of irrigation canals is not satisfactory. For the most part, the channel operating efficiency is 0.45 – 0.73. This is since the bulk of the water in the canals is absorbed by the damp perimeter of the open channel, while some of the water evaporates on hot days [11]. This situation, especially in machine channels, harms the rational use of water and other energy resources. One of the reasons is the technical condition of reinforced concrete slabs to reduce the water permeability of the canals. As an example, defects in reinforced concrete slabs of Khamdam and Dustlik channels were studied (fig.2).

When analyzing the defects in Figure 2 above, we found that cracks and debris of different sizes in reinforced concrete slabs were mainly observed in areas where the water level in the canal varies.

The main reason for this was the loss of freezing of concrete in the body of reinforced concrete and cement mortar at deformation lines. Because the groundwater levels in these canals are variable (1.7... 2.8 m), the mineralization is 0.6... 1.1 g/l. Fractures formed in reinforced concrete coatings are not waterproof if they have a size of 0.4 mm, but in cases where cracks are larger than 0.4 mm, reinforced concrete slabs lose water and freeze water in the pores and capillaries in the winter. The tension is caused by the breaking of concrete and reinforced concrete slabs. Research shows that cracks, cracks, and other breakdowns in concrete pavements can occur for a variety of reasons. Currently, the main causes of this include freezing of free water in concrete, low waterproofing, deformation of temperature and humidity, and finally corrosion of concrete and fittings in reinforced concrete [12,13].

The formation of relatively large cracks and breakdowns in reinforced concrete pavements causes double water filtration in the canals. First, under high hydrostatic pressure, primary filtration occurs when the water level in the canal is reduced, resulting in a decrease in the efficiency of the channel. However, when the water level in the canal decreases, the groundwater levels at the edges of the canal are relatively high and reverse filtration is initiated. As a result of this process, the intensity of mechanical and chemical reactions on the underside of the reinforced concrete coating increases. This may cause the base surfaces on the back of the reinforced concrete slab to become uneven over time. As a result, the reinforced concrete slab will move away from the slab and cause damage to it. In this case, the efficiency of the channels is significantly reduced. Deformation joints between reinforced concrete slabs must be securely closed to prevent this.

To solve this problem, depending on the size of the cracks, they are covered by special cement or fine-grained concrete mixes.
